<b>Products</b>	VIO4K	
<b>Date</b>	JULY 4 <sup>th</sup> , 2016	
<b>Version</b>	1.10.44	Web RCS : 1.10.08

# PREVIOUS VERSIONS

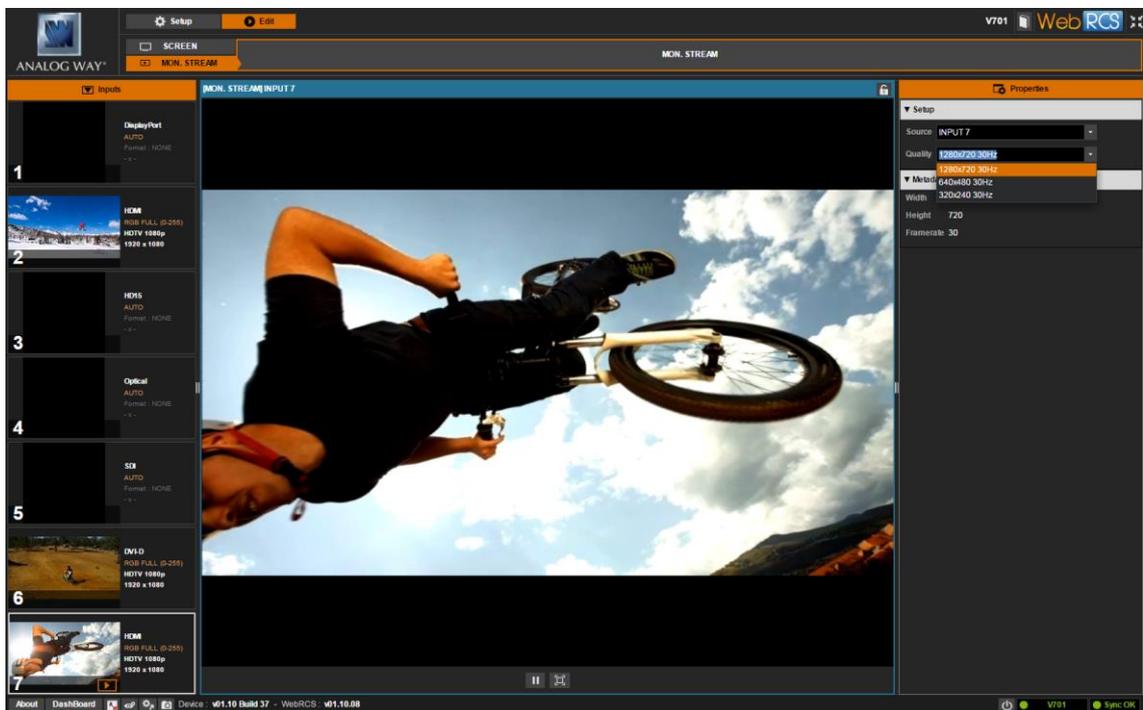
- Add **Monitoring functionality for Inputs and Outputs** to the Web RCS. In the “Edit” tab, select “MON. STREAM” section. Then select a source to monitor: it can be either an input or an output. Finally select the monitoring quality: 320x240@30Hz, 640x480@30Hz or 1280x720@30Hz. Please note that only non-HDCP sources can be monitored.

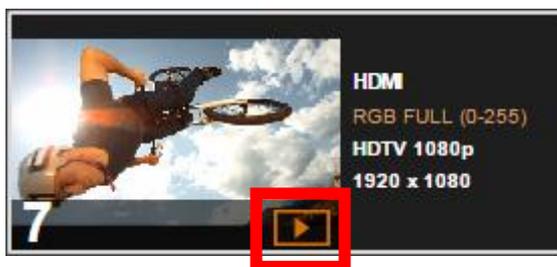
In the left panel containing the input status and snapshots, a small icon indicated that an input is currently being monitored.

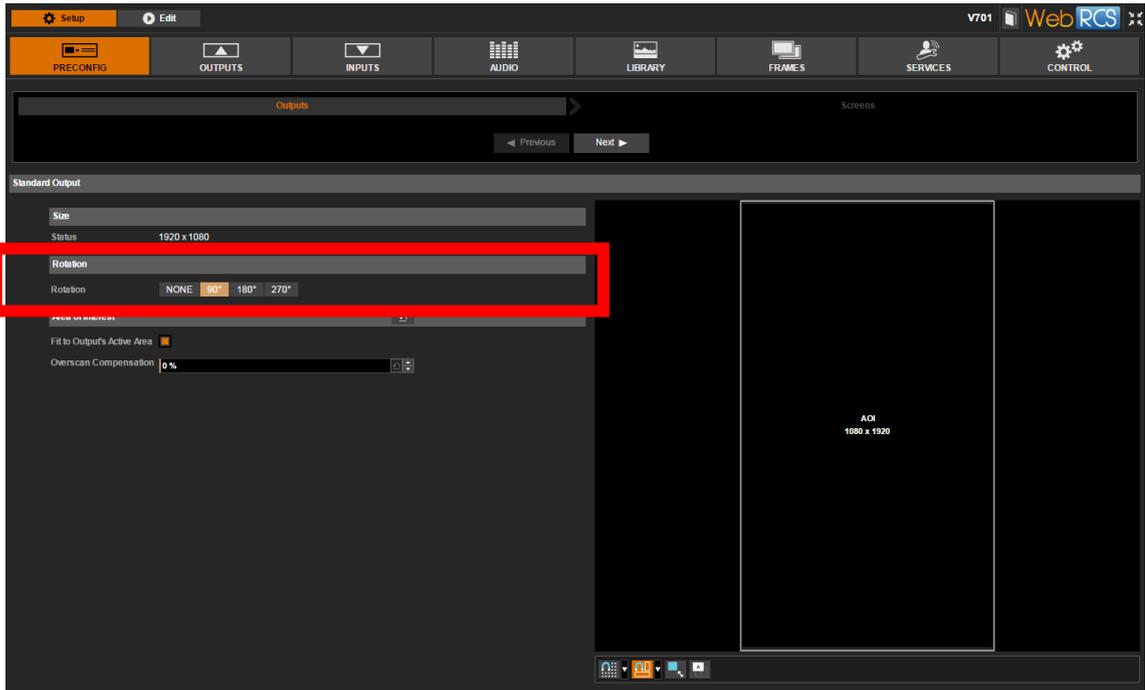
- **Rotation** support for outputs and Frames. In the “Setup” tab, the output content can be rotated by 90° steps.

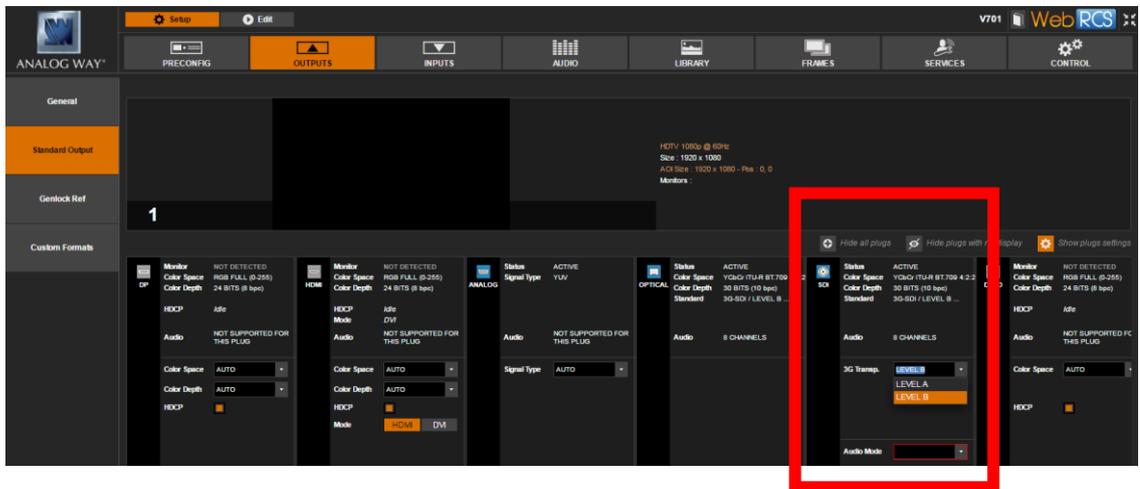
- Implementation of **3G-SDI Level B** for SDI and optical output plugs. In the “Setup” tab, this settings can be found in the plug settings of the output

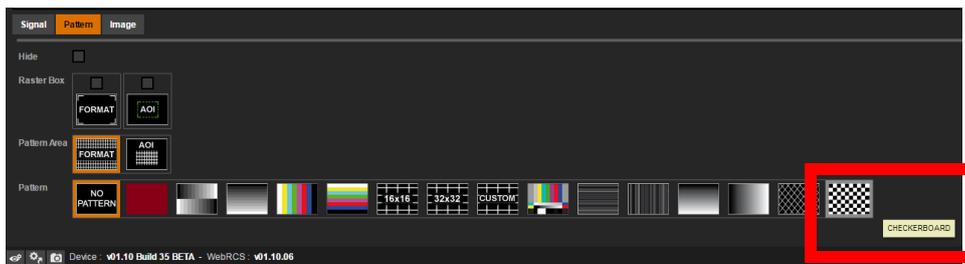
- Add **Checkerboard** test pattern. To use this new pattern, the “Pattern menu” of the selected output.

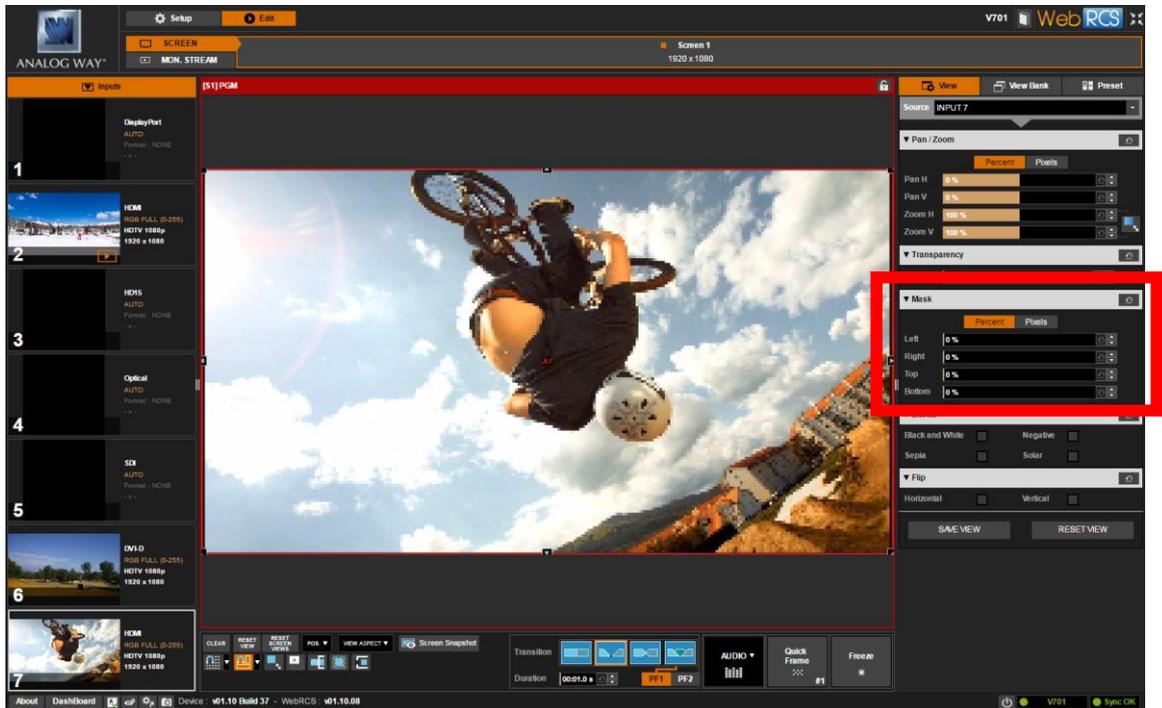
- **By default, the Low Latency mode of the deinterlacer is enabled.** By default, the deinterlacing process used for interlaced input signals doesn't add any extra frame delay. When disabling the low latency mode, the deinterlacer algorithm changes and improves the image quality but adds one extra-frame latency.
- Add Mask parameters to "View" settings to allow an individual crop for each outputs

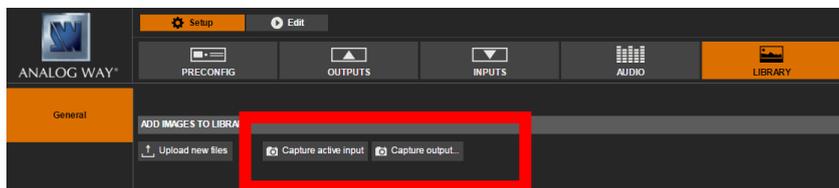
- Add the possibility to capture inputs and outputs

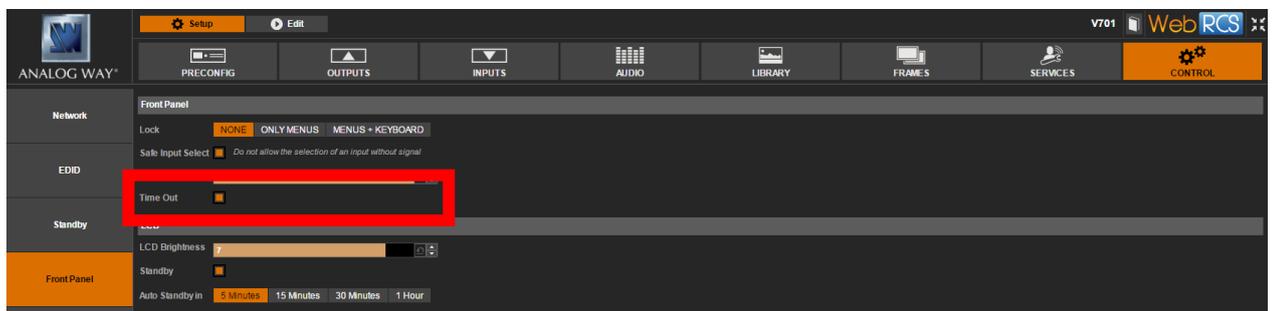
- Add a user menu to disable or not front panel menu timeout
